### EROSION + SEDIMENT CONTROL

## FIELD GUIDE

### BEST MANAGEMENT PRACTICES

To be used as part of a  
Construction Site Erosion + Sediment Control Program

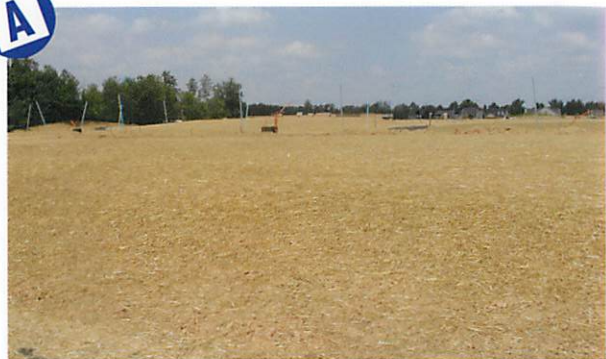
Good straw coverage.

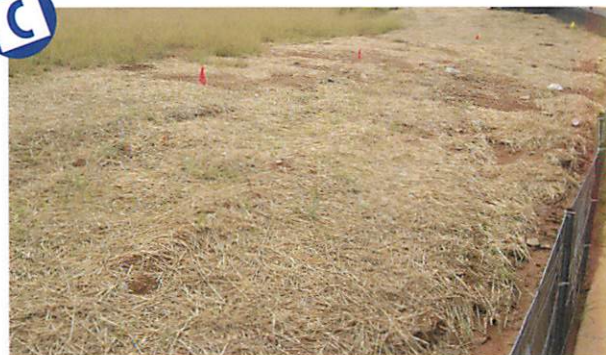
Good coverage of mulch and temporary grass, but runoff has exposed some areas.

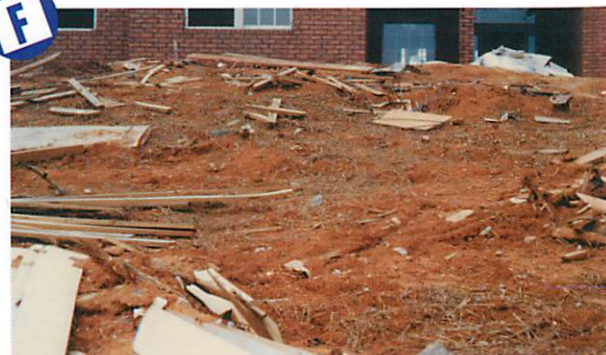
Completely inadequate coverage.

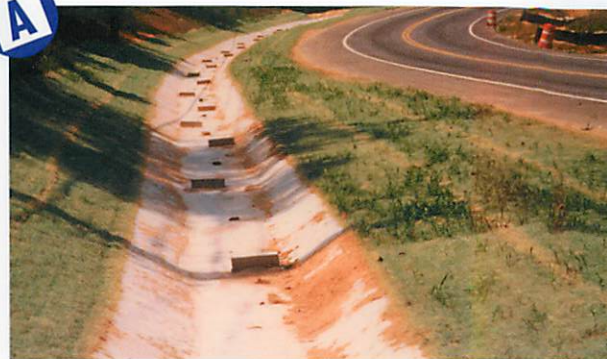
Excellent coverage with synthetic mats and vegetation.

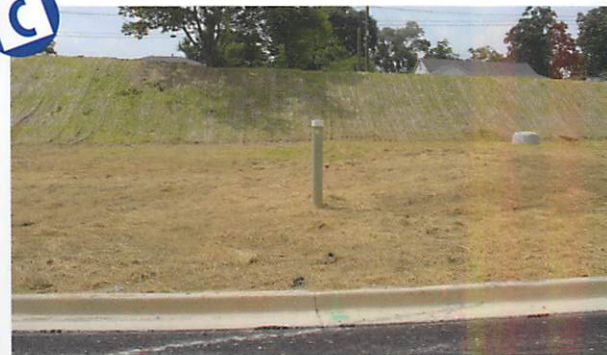
Matting applied to slopes, some areas exposed. Vegetation beginning, watering needed. Mulching in foreground pretty good.

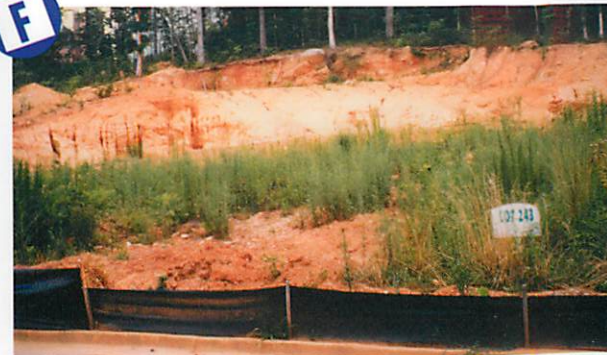
Poor vegetative cover. Large bare spots. Extensive erosion taking place.

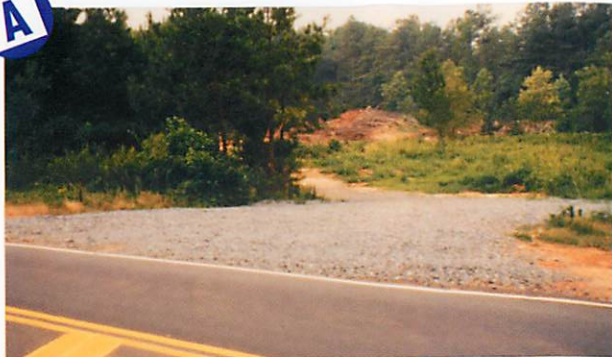
A

Excellent stone coverage.  
No mud tracking onto roadway.

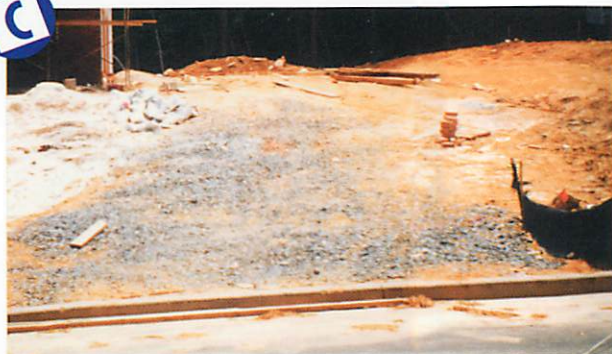
C

Fair stone coverage.  
Some mud tracking onto roadway.

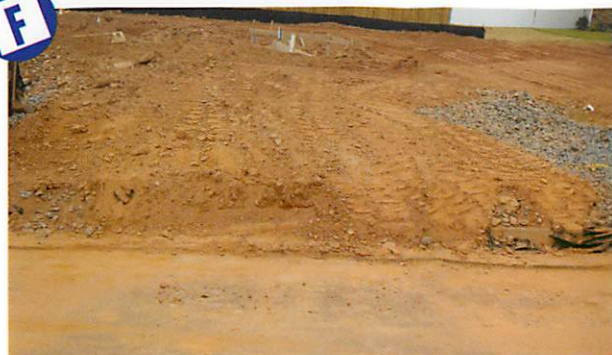
F

Very poor stone coverage.  
Significant mud tracking and flowing onto roadway.

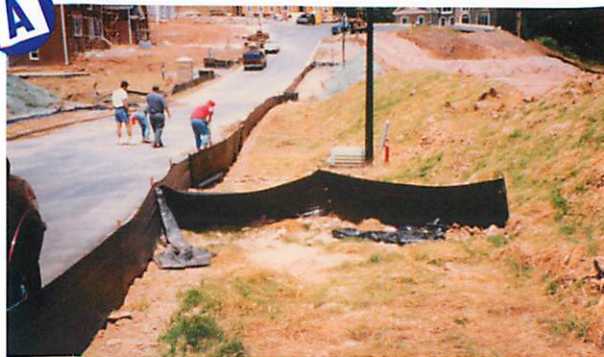
A

Excellent silt fence installation.

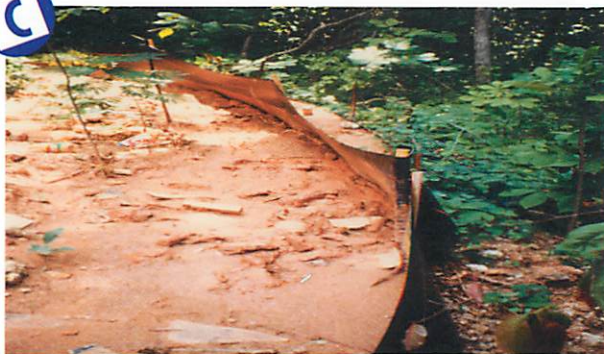
C

Silt fence adequate: but sediment needs to be removed from behind fence.

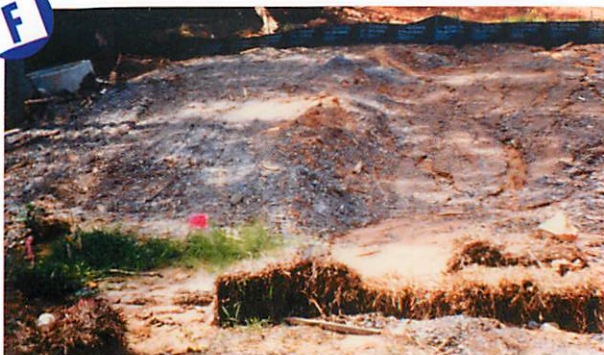
F

Complete barrier failure.  
Significant quantities of sediment passing this barrier.

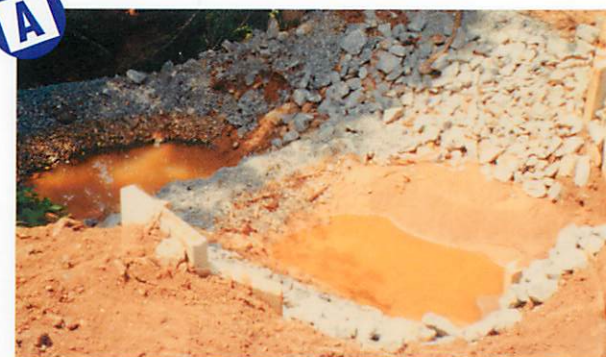
A

Excellent application with two filter dams.  
Look for signs of structure working such as sediment trail.

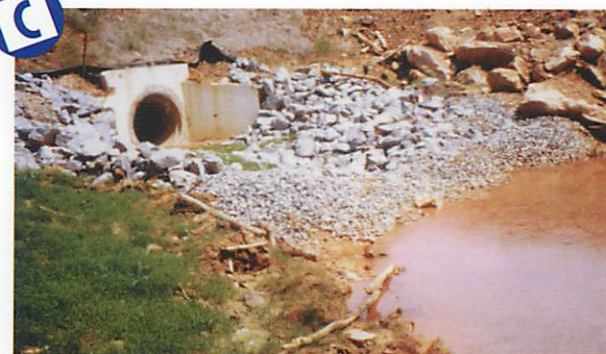
C

Good application, but height inadequate.

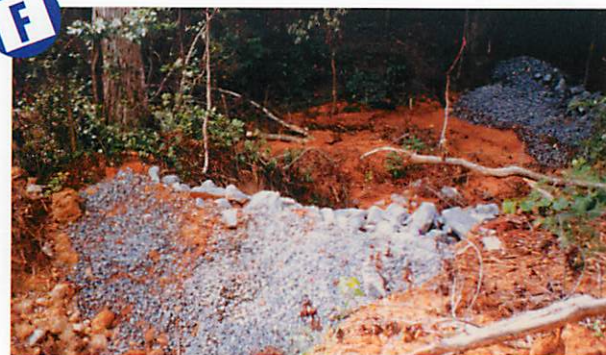
F

Poor application. Virtually unmaintainable without significant disturbance.  
Removal of feature at completion very difficult.

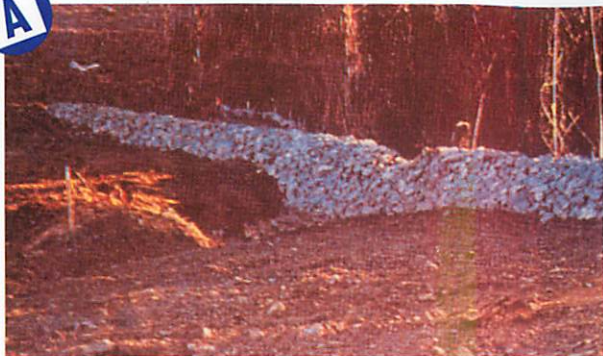
A

Excellent placement, sizing, and overflow notch.

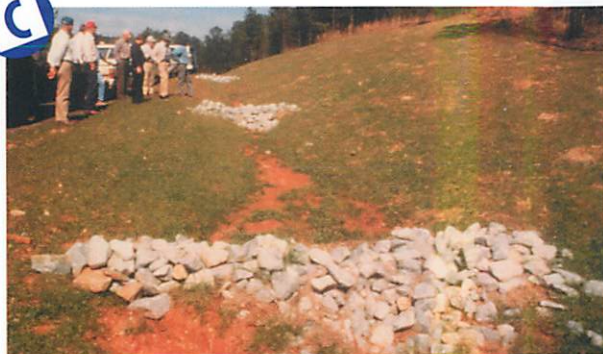
C

Should be lower in center to direct flow.  
Needs to be cleaned out prior to complete vegetation.

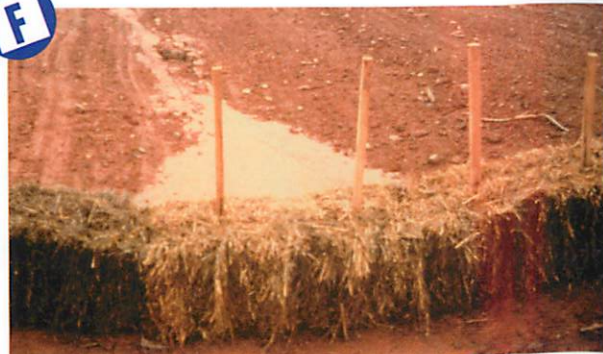
F

Use of hay bales is not appropriate for sediment control.  
Water easily migrates under bales causing failure.

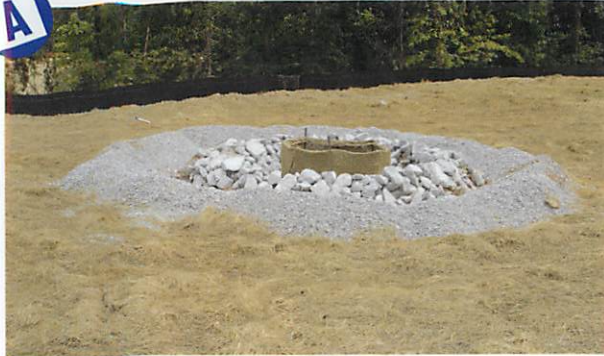
A

Excellent stone sizing and placement.  
Note: good surrounding soil coverage with mulch.

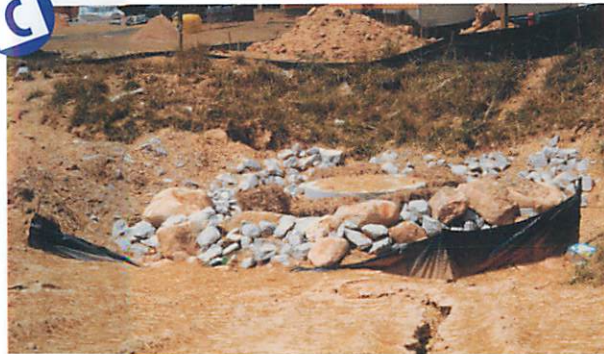
C

Rill erosion beginning in foreground (concentrated flow). Silt fence down.  
No small stone for filtering.

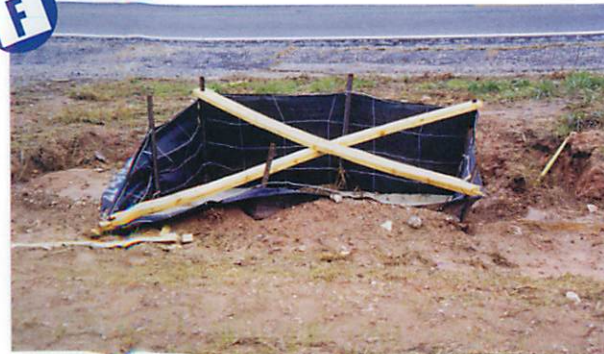
F

Very poor maintenance. No protection.

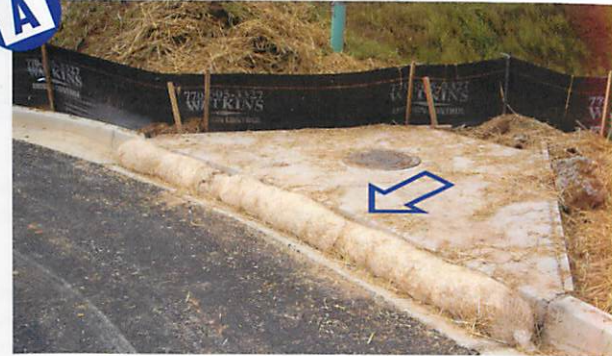
A

Excellent use of spacers. Proper maintenance.

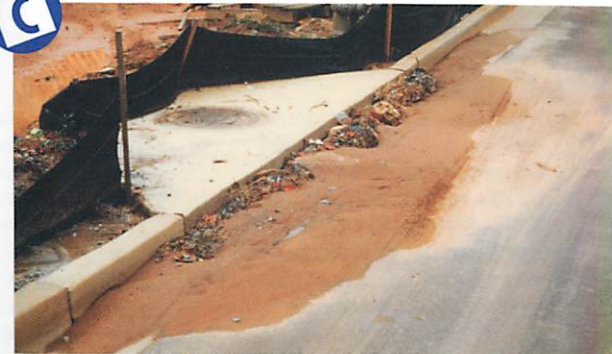
C

Good application, but needs to be cleaned out to function properly.

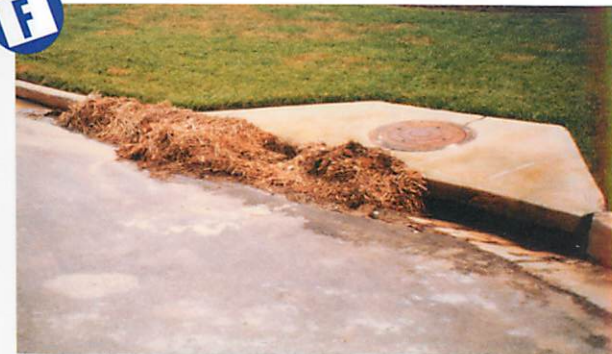
F

Poor inlet protection. Hay bales do not last very long.  
May clog inlet or pipes.

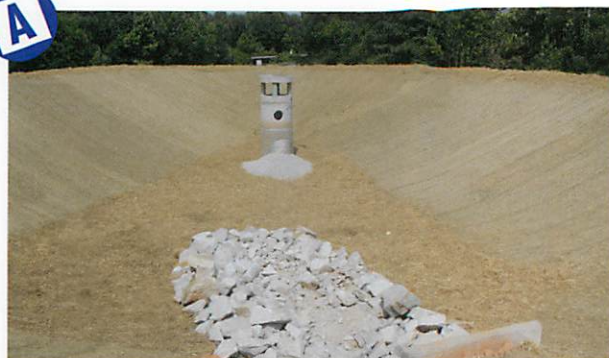
**A**

Perforated standpipe with gravel filter in place.

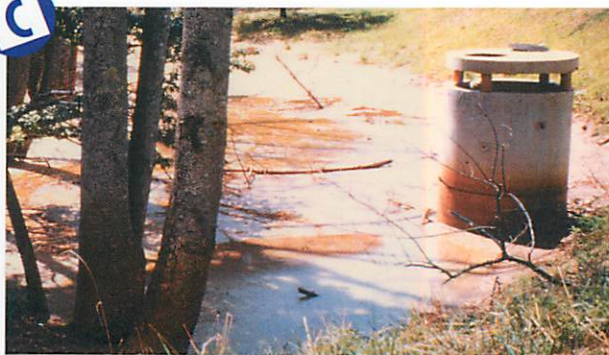
**C**

Poor outlet geometry.  
 Potential maintenance problem.

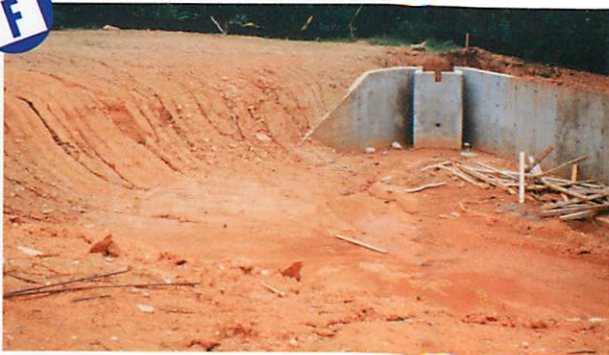
**F**

No vegetation.  
 Perforated standpipe with gravel filter is missing.

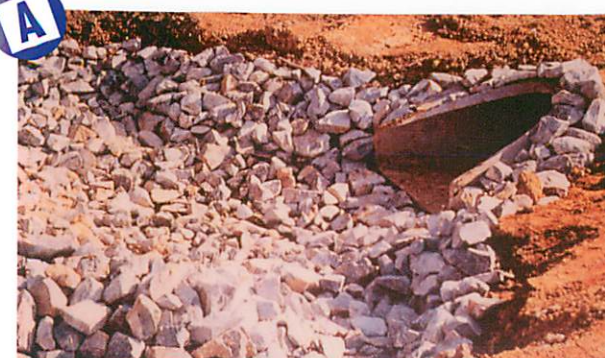
**A**

Excellent coverage, sizing, and placement.

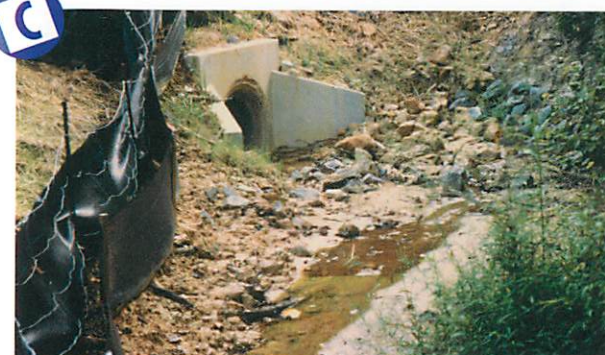
**C**

Poor geometry.  
 Inadequate stone coverage.

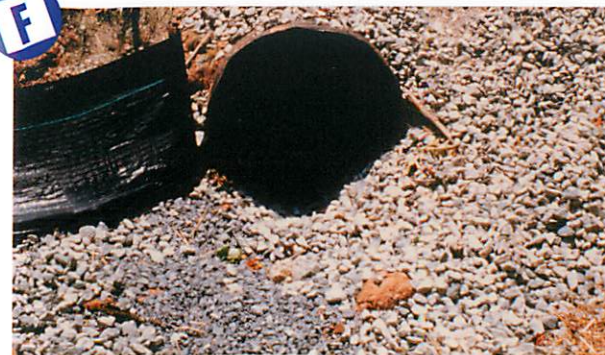
**F**

Very poor stone coverage.  
 Entire channel should be protected.
